Reconstructing the damage field of the 1855 earthquake in Switzerland: historical investigations on a well-documented event

Stefan Fritsche, Donat Fäh, Monika Gisler and Domenico Giardini

Swiss Seismological Service, Institute of Geophysics, ETH-Hoenggerberg, HPP L4, 8093 Zurich, Switzerland. E-mail: stefan.fritsche@sed.ethz.ch

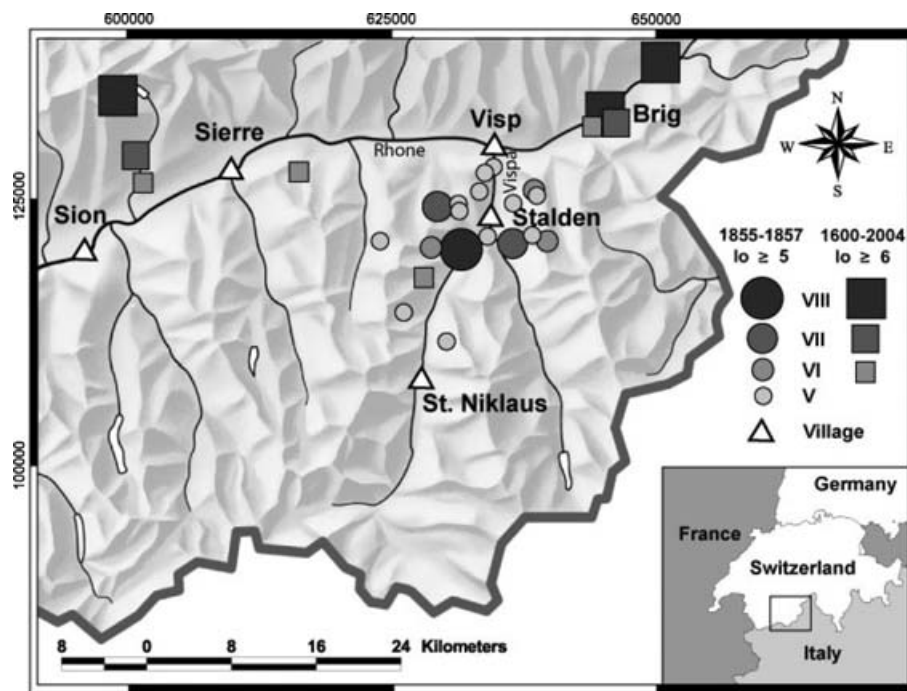
Figure 1. Historical seismicity of the investigated region in the middle Valais.

nation but also in other parts of Europe. The extent of damage was remarkable and is still unsurpassed in the Valais. The large quantity of available contemporary source material such as newspaper and scientific journal articles, travel diaries and entries in chronicles is, therefore, not surprising. Most known of these sources is the dairy of Pastor Moritz Tscheinen (1857). Tscheinen was an eyewitness living in Törbel, a small village in the epicentral area. With high accuracy, Tscheinen listed the series of main and aftershocks by notifying the date, time, strength and manner of the felt events (Table 1 and Fig. 1).

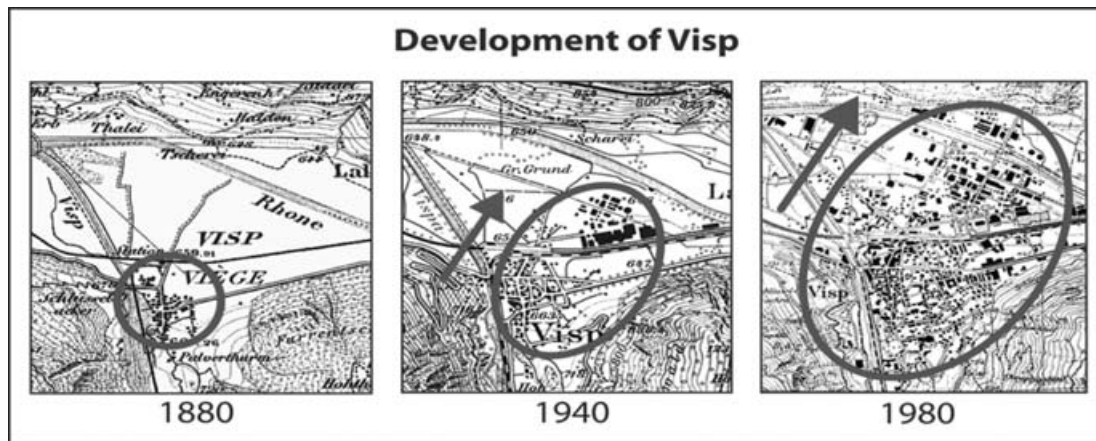
Figure 2. Development of Visp from 1880 to 1980.

attractive places for expanded settlement in the last two centuries: river regulations allowed many villages and cities to grow extensively on these wide plains, as they do in the Rhine Valley or the Valais (Fig. 2). The risk to settlements is therefore increasing. Further research into the relation between damage and possible site effects is definitively merited.

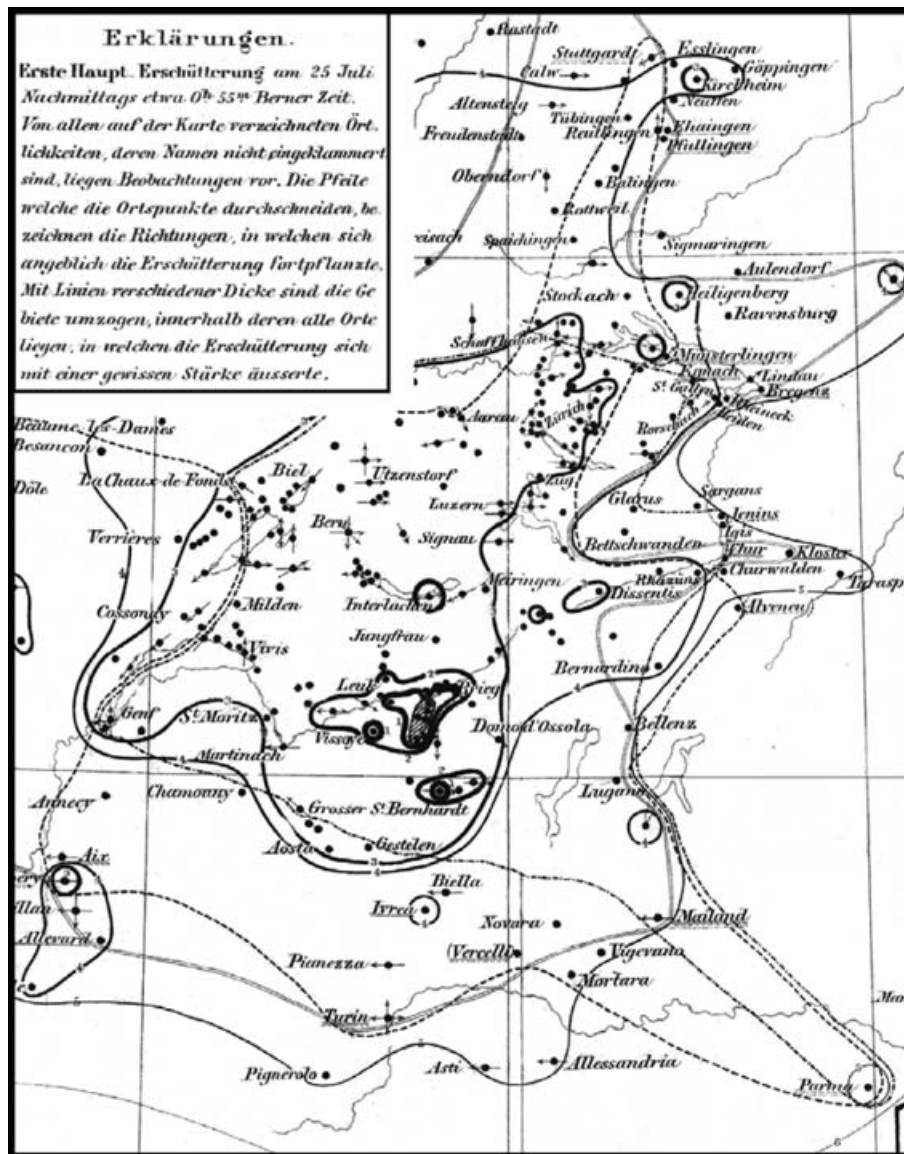
Figure 3. Part of the isoseismic map of Volger with a scale from 1 (heavy destruction) to 6 (felt). (Volger 1856).

In a few cases he noted information about the damage. Another well-known and important source is the work of the German mineralogist and geologist Otto Volger (Volger 1856). Volger (1822–1897) worked several years on historical earthquakes in Switzerland. A comprehensive publication in 1857 dealt with earthquake phenomena in Switzerland in general (Volger 1857), another publication with the 1855 earthquake in particular (Volger 1856). Remarkable for example is his ‘macroseismic map’ of the 1855 event: an early form of an isoseismic map (Fig. 3).

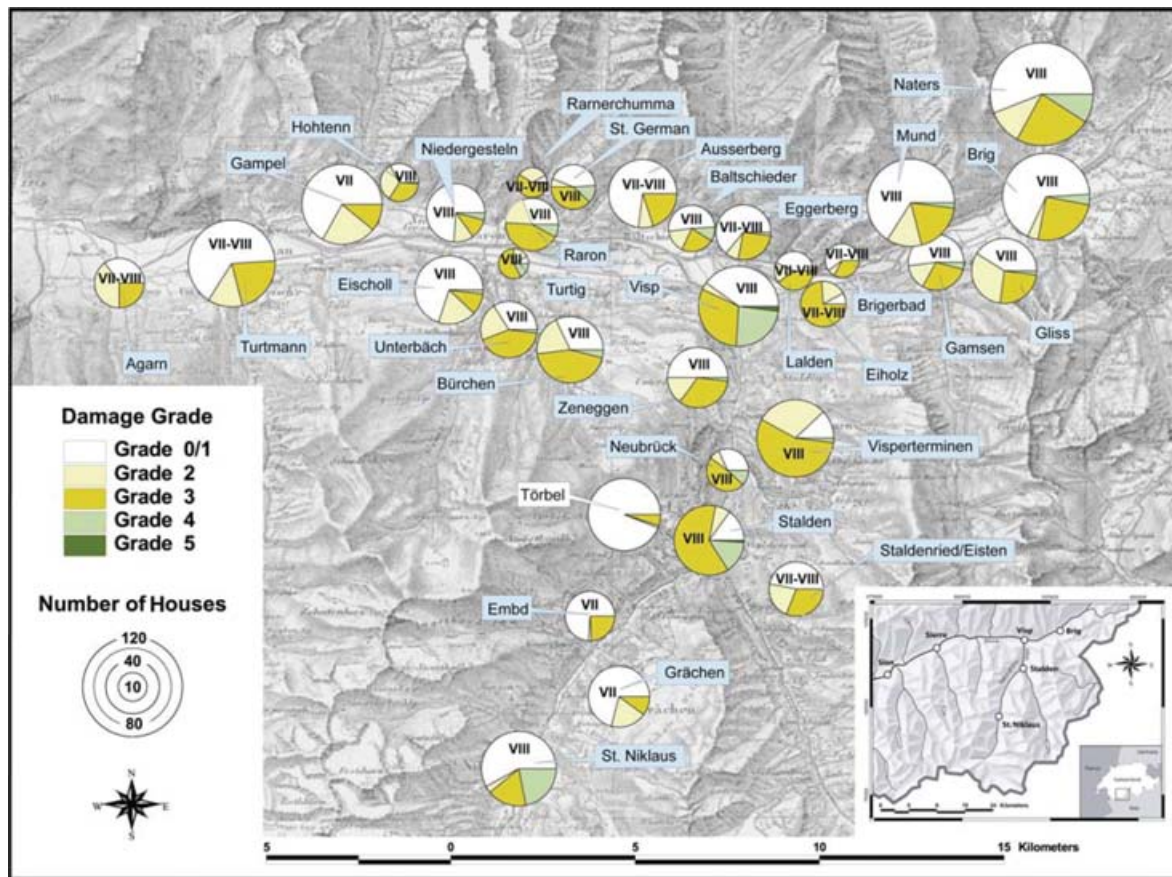
Figure 8. Damage grades and intensities assigned on the basis of the damage lists. For locations with intensity degrees in the form of VII–VIII, it was not possible to decide which value is appropriate. They contain elements of intensity degrees VII and VIII. (Grünthal 1998, p. 57).

Fig. 8 summarizes the results of the assessed damage field on the background of a reproduced map (1:100 000) first published in 1854 (Bundesamt für Landestopographie 1988). The investigated regions are plotted as pie charts. Their size is proportional to the total number of existing houses at that time. The coloured segments indicate the different damage grades. As mentioned, damage of levels 1 and some of 2 were not assessed and are, therefore, included in the white coloured segment representing the undamaged buildings. The assigned intensity degrees are represented by roman numerals. Before going into detail, we will compare this figure with the descriptions and comments in paragraph 4 (an overall description of the damage field pp. 11–17). Two differences are obvious. While the highest intensities in Fig. 8 are of grade VIII (heavily damaging), an assignment of intensities on the basis of the quotations in paragraph 4 would instead produce intensities of up to grade IX (destructive).

On the other hand, the geographic range containing assured information about losses in this paragraph is much smaller than shown in Fig. 8. These are typical phenomena in the context of historical data: historical documents often address a broader public focus in considering the most remarkable or newsworthy effects of an earthquake (Grünthal 1998, 52), particularly if the society believes the

After a closer look at Fig. 8, the following deserves attention. According to EMS 98 damage occurs in the range of intensity VI and higher (Grünthal 1998, 18–20). However, our damage field shows no intensities of degree VI, not even on its borders. This is due to the fact that intensity VI is defined by damage of grades 1 and 2, which did not (or only partly) match the criteria to obtain compensation payments. Thus, we have to assume that outside the figure border localities showing intensities of degree VI were present in 1855. Fig. 9 is based on several earthquake catalogues and confirms this assumption, showing the investigated region as part of the entire macroseismic field.

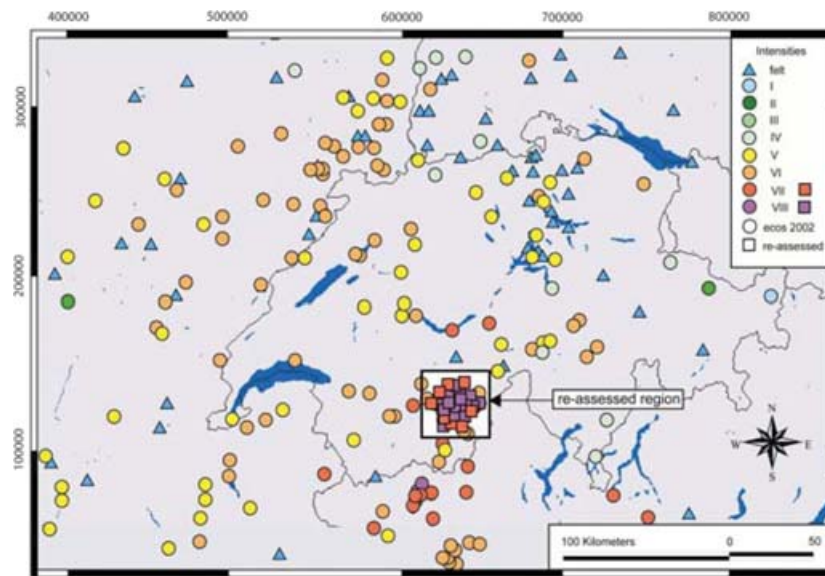
Figure 9. Investigated region as part of the entire macroseismic field of 1855. The data for this analysis derive from the revised Earthquake Catalogue of Switzerland (ECOS) (Swiss Seismological Service 2002), from the Italian Catalogo parametrico dei terremoti italiani (Istituto Nazionale di Geofisica 2005) and from the French catalogue SisFrance (BRGM *et al.* 2005).

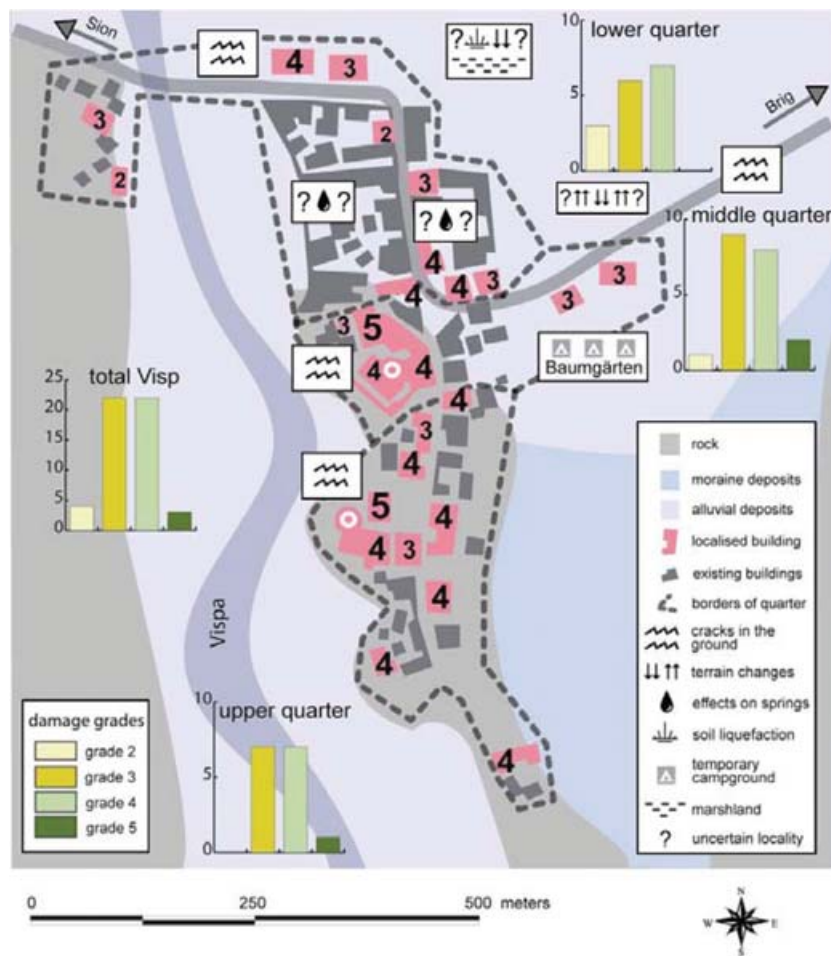
Fig. 10 summarizes the results of this historical investigation against the geological background. Exactly located buildings are marked in red. The corresponding number specifies the assigned damage grade. In contrast to this, the black coloured houses do not represent the exact situation as it was in the 1850s, but indicate the area of the historical village. The dotted line represents the borders of the historical quarters, as they could be reproduced on the basis of the 1870 census documents. Finally, the bar charts summarize the damage per quarter including that to houses whose location is not exact. All the still existing houses are built in simple stone masonry and belong to vulnerability class B. We assume as well that most buildings no longer existing fit into this category. Indications for this assumption can be found in the photograph of Visp (Fig. 11) published by Fux (1996).

Figure 10. Geology, localized buildings, dispersion of damage and approximate position of seismogeological effects in Visp.

ble to identify their former position. We were able to locate exactly about 50 per cent of the houses mentioned in the damage lists. Approximately 20 per cent could be assigned to one of three parts of the township (see Fig. 10). This detective work was based upon comparing the damage lists to the original documents of the 1850 population census (Eidgenössische Volkszählung 1850, Gemeinde Visp) and 1870 (Eidgenössische Volkszählung 1870, Gemeinde Visp). However, even more important than these documents was the help of the local historian, Christian Fux. His profound knowledge of Visp, its history, and families was indispensable to the completion of this work.

The bar charts show that the distribution of damage grades is very similar in all three parts of Visp. This is astonishing when we consider that the geological situations of the upper quarter (built on rock) and the lower (built on the large deposits of the main valley) differ significantly. Because of amplification effects, we had expected that more serious damage would have occurred on the deposits than on the rock. The assumption that a site effect played a major role in the damage distribution in Visp is thus not yet verifiable. A possible explanation for the equal distribution of the damage is a source effect. This thesis would agree with the fault postulated by (Crealp 1999) and Joris (2005). However, to understand better what really happened in the Visp of 1855, we plan to further investigate

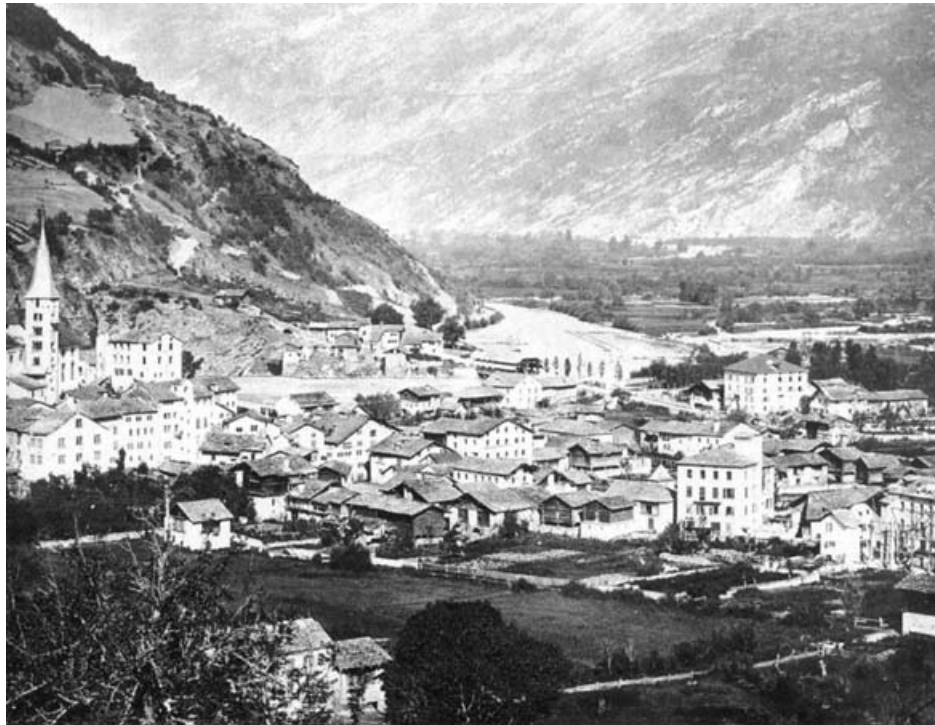
Figure 11. Photograph of Visp in 1856 (Fux 1996, no. 195). Some of the buildings still show damage caused by the earthquake or are under reconstruction.
